SUBJECT: TSCA PCB Inspection Reports for Kingdome Investigation
(Total Reclaim and Turner Construction)

**TOTAL RECLAIM INC.
SEATTLE, WASHINGTON
TSCA /PCB INSPECTION**

INSPECTION DATE: April 21, 2000

INSPECTOR: Eileen Hileman
Investigations and Engineering Unit
Office of Environmental Assessment
EPA Region 10

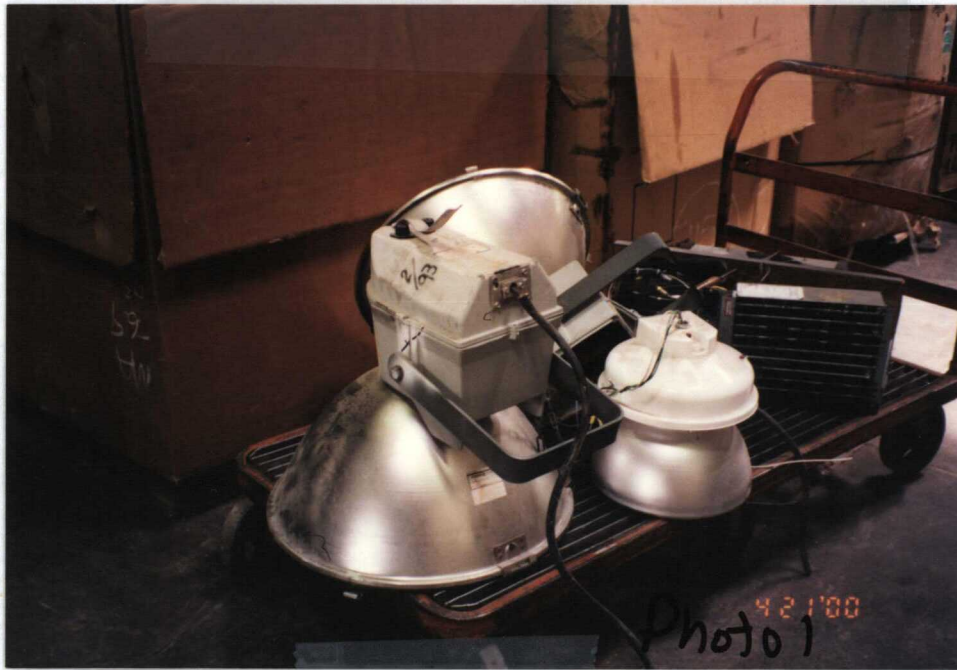
Photograph 1 taken by Eileen Hileman on April 21, 2000, at Total Reclaim, Seattle, Washington. Photograph 1 shows the type of light fixtures that were in the light ring within the Kingdome. These lights that were removed contained non-PCB ballasts.

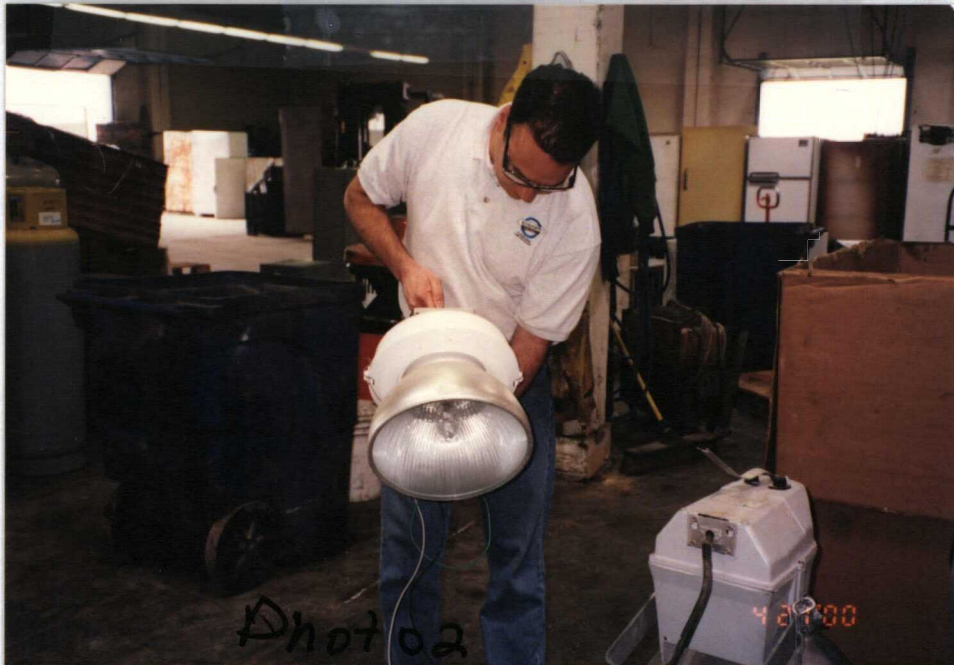
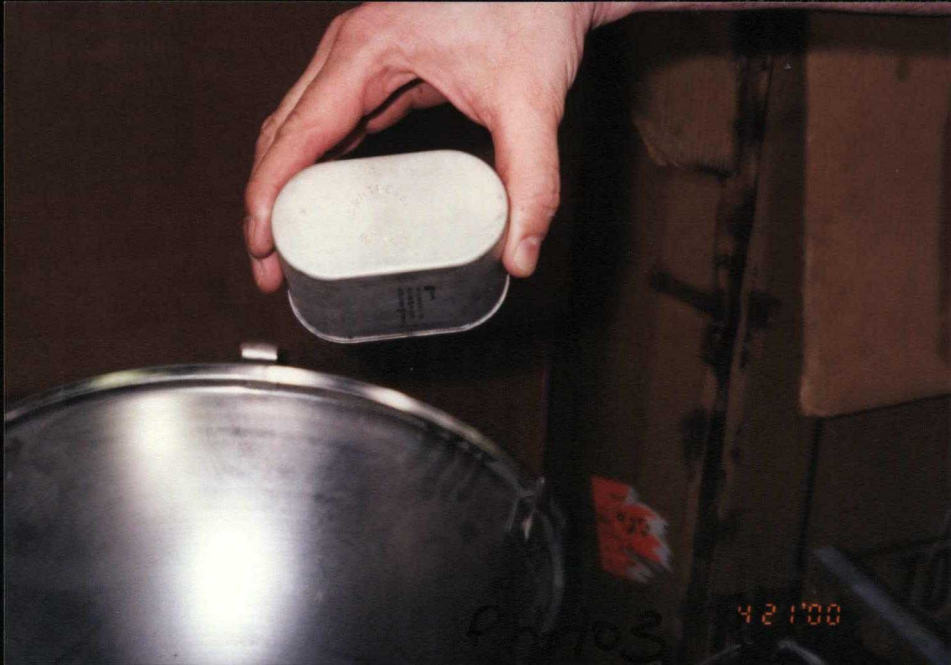
Photograph 2 taken by Eileen Hileman on April 21, 2000, at Total Reclaim, Seattle, Washington. Photograph 2 shows an type of hanging lamp that was also in the Kingdome.

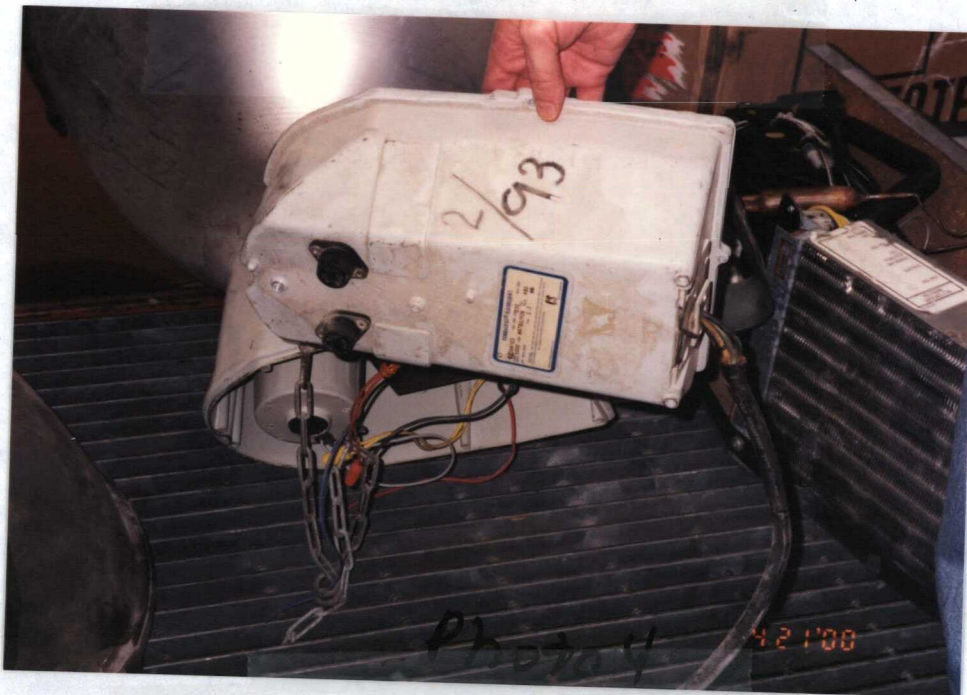
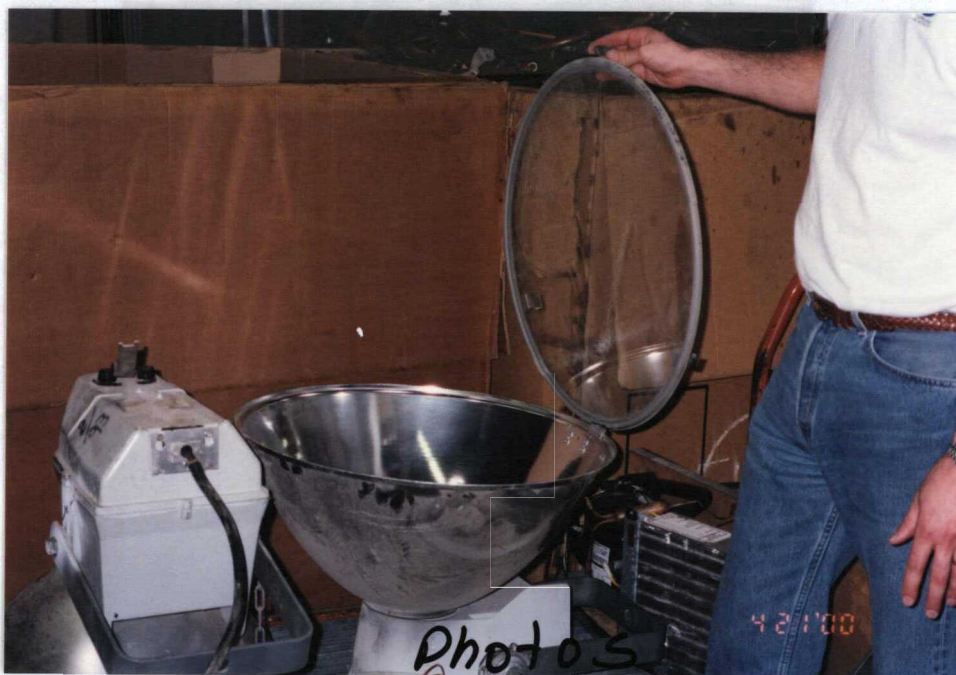
Photographs 3 and 4 taken by Eileen Hileman on April 21, 2000, at Total Reclaim, Seattle, Washington. Photographs 3 and 4 show a non-PCB capacitor and cover.
